Pasture Field Lane – Parish Council concerns – updates.

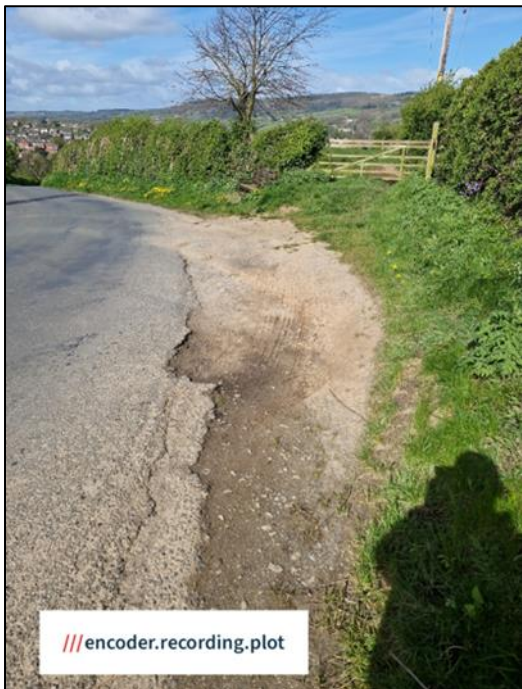
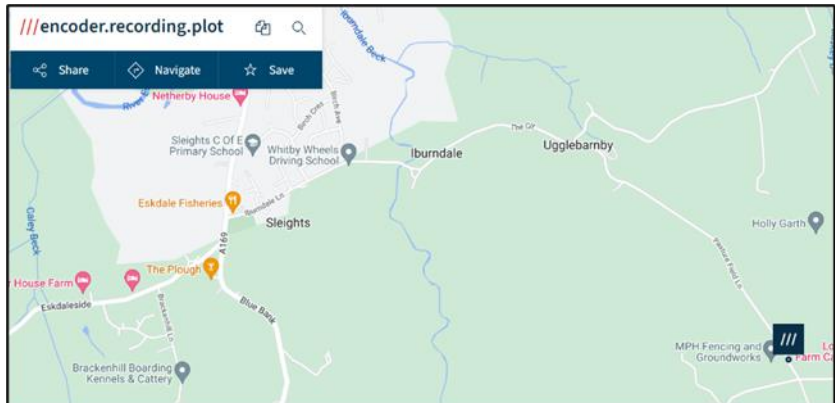
1.

The What3Words street view image does not look like this photograph, so I am not sure if the location is correct. I have shown the defect to our Senior Engineer, and they commented that the defect is off the highway – this passing place or pull in is unofficial and its use has caused the defect which will be monitored during the routine safety inspections.

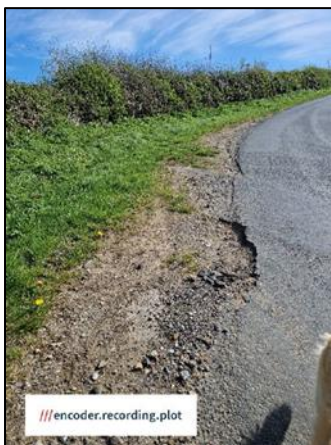
2.

Same location as above.

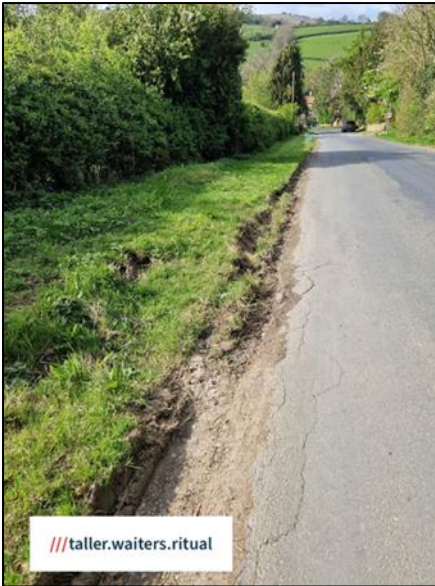
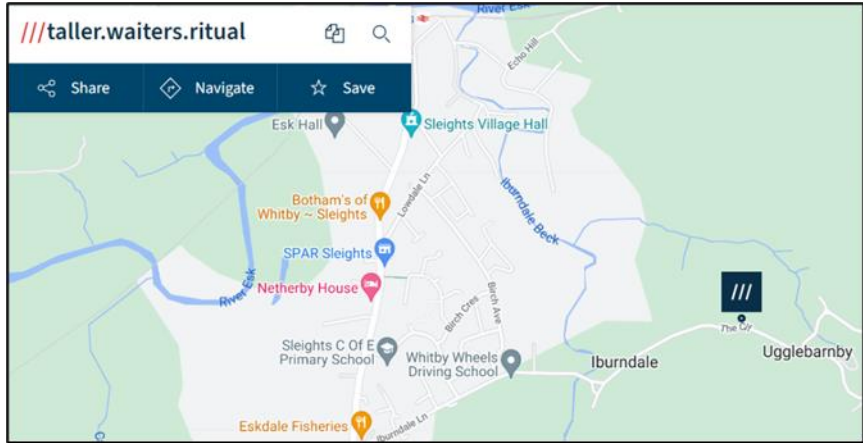
3.

Verge over running damage – not at intervention levels unless there is a difference of 20cm we would not take any action and then all we could do was to pull the verge back to the edge of the carriageway.

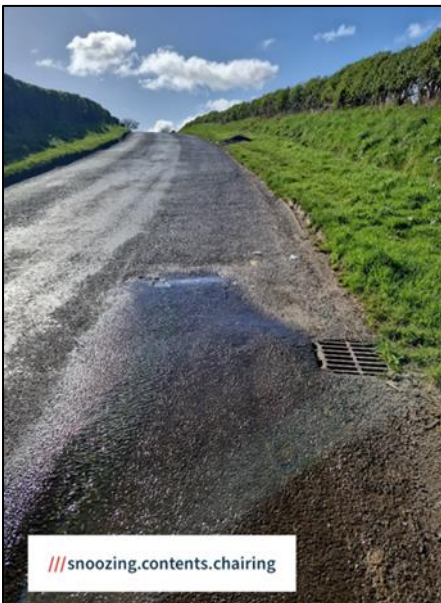
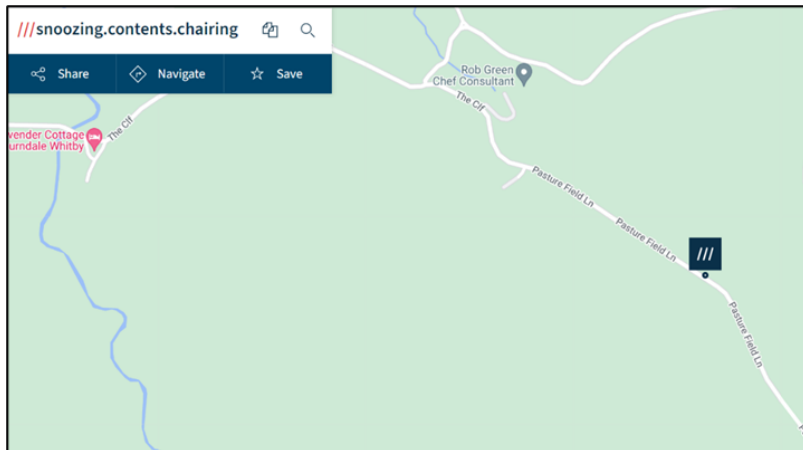
4.

We are not quite sure what the defect is here that the PC are reporting. If it is a possible water leak, then could you please report this to Yorkshire Water.

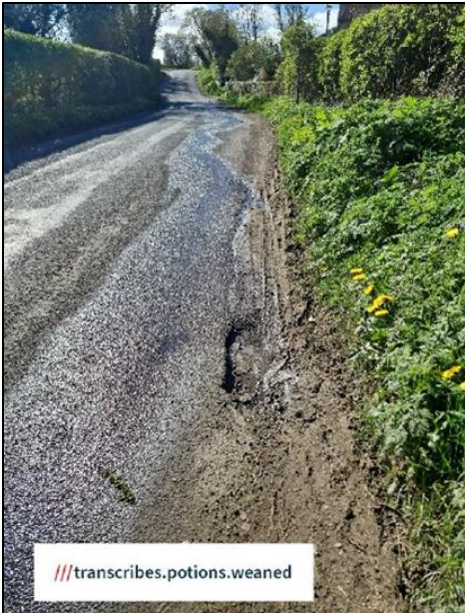
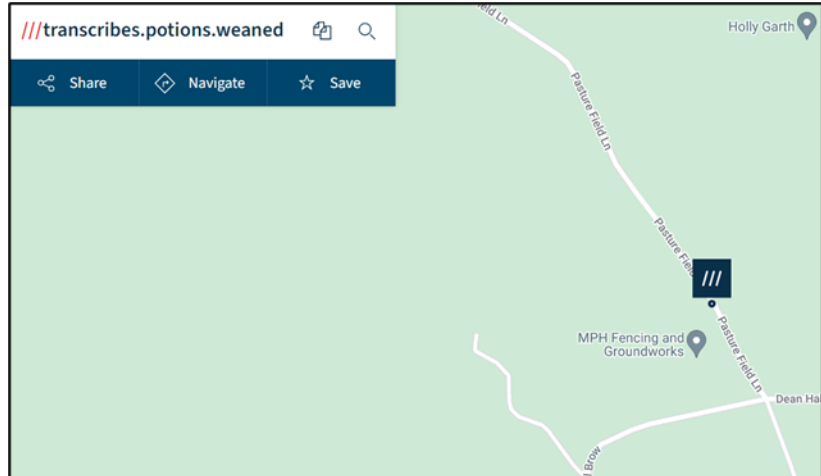
7.

We suspect that this is again edge damage caused by vehicles over running the highway verge. We have asked the local highways officer to inspect the defect. There also seems to be quite a lot of water coming out of the field in the top left of the picture – the landowner would need to take action here to prevent water from their land getting onto the highway.

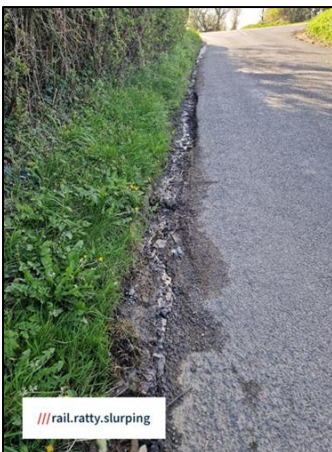
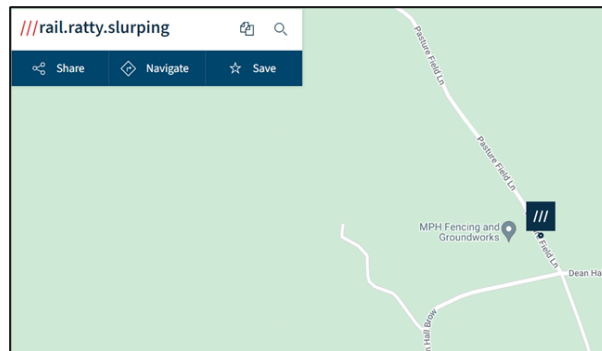
9.

The image shows water running down the highway verge – if this is coming from the land this needs to be addressed by the landowner.

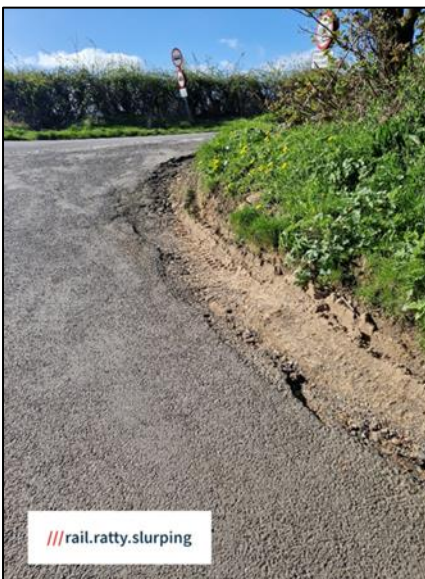
10.

Same location as No.9 above according to What3Words location details. Verge damage caused by vehicles over running the verge – poor driving – we will not be taking any action here.

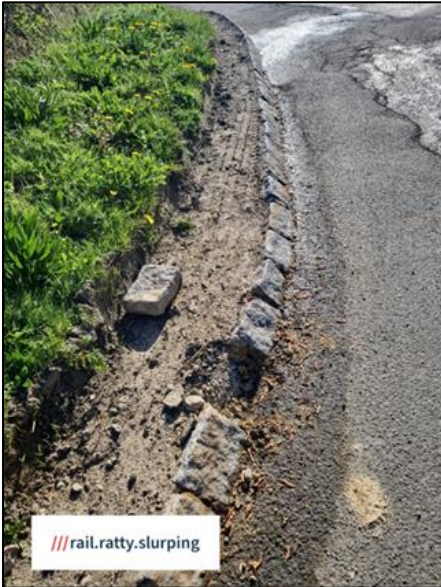
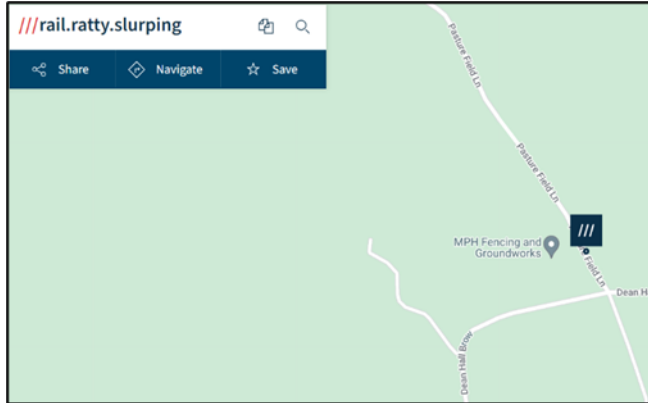
11.

Same location as 9 & 10 above – again damage caused by poor driving – case raised for the highway officer to inspect and arrange the necessary repairs.

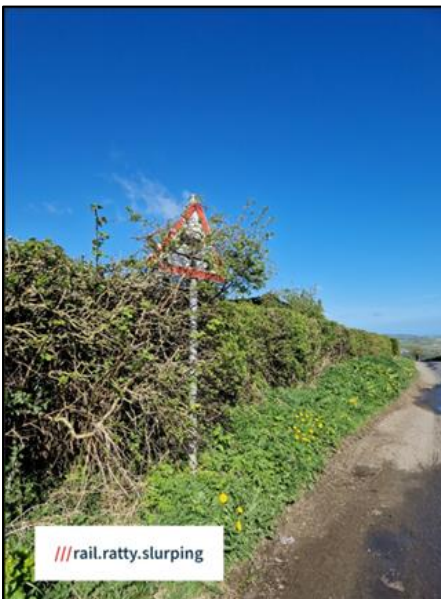
12.

Same location as 9, 10 and 11 according to What3Words location – I don't think this can be correct – anyway – this is down to the landowner to sort out. It looks as though the farmer has cut back their hedges and left the growth around the sign rather than getting out and cutting down the hedge near the sign. If the PC know who the landowner is can you contact them, please.
